Manhole Inspection Summary

Manhole # S31E__028MH

Insp Date: **12/16/08 8:56 AM**

Location Address: **520 N Paca St**

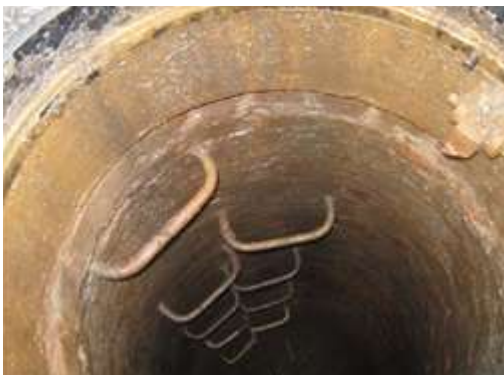
Defect 1

Condition: ☐ Sound ☐ Cracked ☒ **Leaks**

Infiltration: ☐ None ☒ **Joint** ☐ Cracks ☐ Mortar ☐ Roots ☐ Wall

lid/frame and chimney infiltration

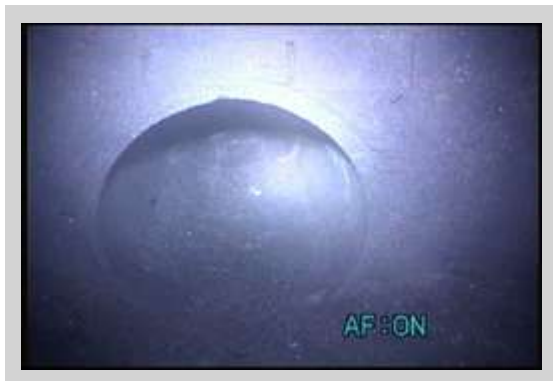
12 O'Clock Outflow

10 in. Circular Gravity Sewer
Pipe Out @ 12 O'Clock
